## Inspection and/or replacement of the valve push-rod assy., rocker arm left and rocker arm right for ROTAX® Engine Type 912 i, 912 and 914 (Series)

ATA System: 72-30-00 Cylinder head

## SERVICE BULLETIN

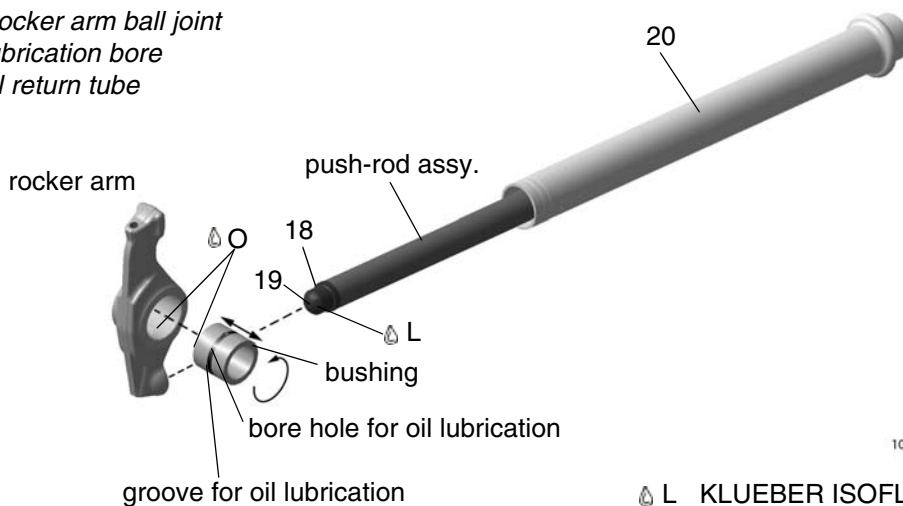
Fig. 3

18 Rocker arm ball joint  
19 Lubrication bore  
20 Oil return tube

See [Fig. 2](#) and [Fig. 3](#).

13	NOTE: Only when you have an Criterion B) Spare parts affected engine and only if engine is equipped with collar cap nuts M8 wrench size 13: Mount collar cap nut (6) according to latest Maintenance Manual Heavy or SI-912-025/SI-914-026/SI-912 i-010.
14	Lubricate all moving parts in the rocker arm space with engine oil or equivalent.
15	Clean the sealing surface of cylinder head and valve cover with a suitable lint-free cloth or equivalent.
16	Insert new O-ring (4) 105x2.5 and O-ring (5) 6.4x1.8 into the valve cover (3).
17	Fit valve cover.
